PHASE I INSPECTION REPORT  
NATIONAL DAM INSPECTION PROGRAM

Hawstone Dam: NDI I.D. No. PA-00580

Owner: John Hostetter  
State Located: Pennsylvania (PennDER I.D. No. 44-7)  
County Located: Mifflin  
Stream: Unnamed Tributary to the Juniata River  
Inspection Date: 26 November 1979  
Inspection Team: GAI Consultants, Inc.  
570 Beatty Road  
Monroeville, Pennsylvania 15146

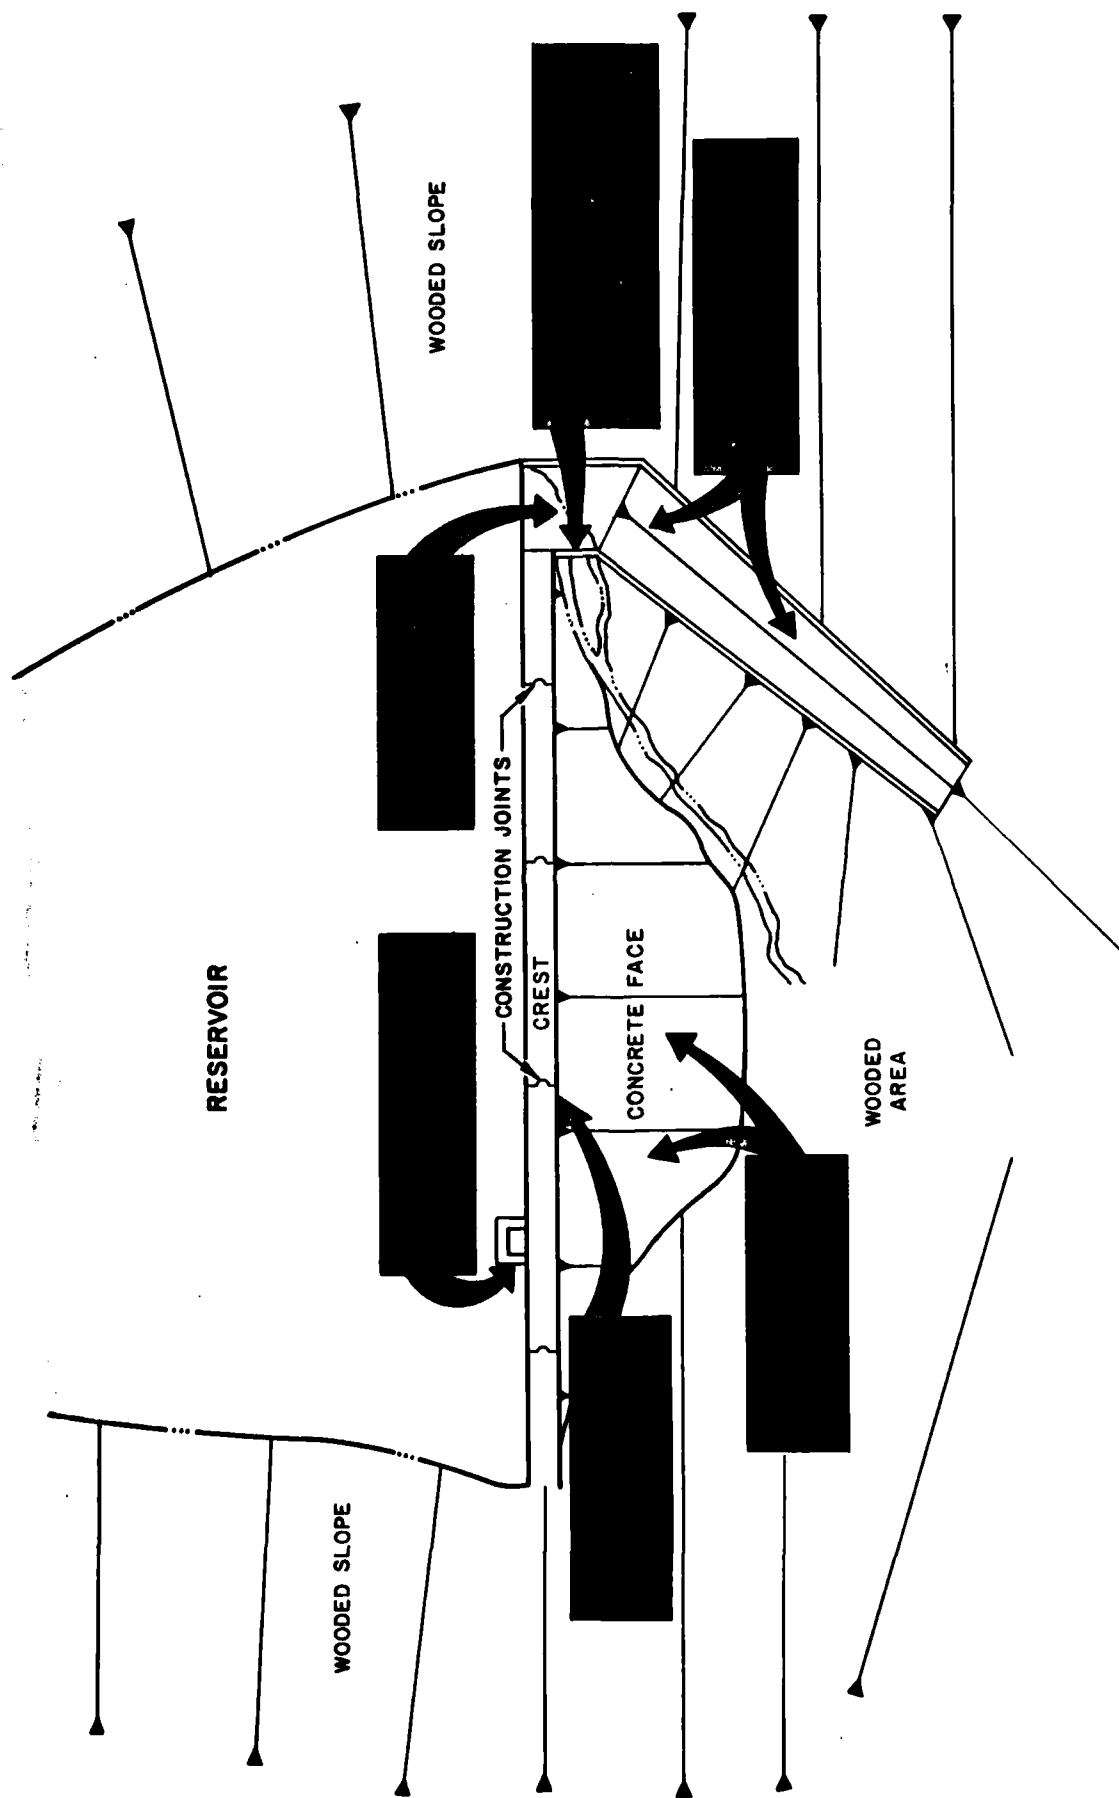
HAWSTONE DAM  
GENERAL PLAN - FIELD INSPECTION NOTES

ITEM	OBSERVATIONS/REMARKS/RECOMMENDATIONS	NDI# PA · 00580
SLOPES: RESERVOIR	The general surrounding area is characterized by steep rocky slopes that are heavily forested. No signs of slope distress observed.	
SEDIMENTATION	None observed.	
DOWNSTREAM CHAN- NEL (OBSTRUCTIONS, DEBRIS, ETC.)	The dam is situated about 800 feet off the Juniata River. Normal stream flow passes through small culverts beneath PA Route 333 and three active tracks of the Penn Central railroad prior to reaching the Juniata River.	
SLOPES: CHANNEL VALLEY	Steep, narrow, wooded valley.	
APPROXIMATE NUMBER OF HOMES AND POPULATION	No permanent or temporary structures occupy the area between the dam and the Juniata River approximately 800 feet downstream. PA Route 333 crosses the stream immediately below the dam as do three active tracks of the Penn Central Railroad.

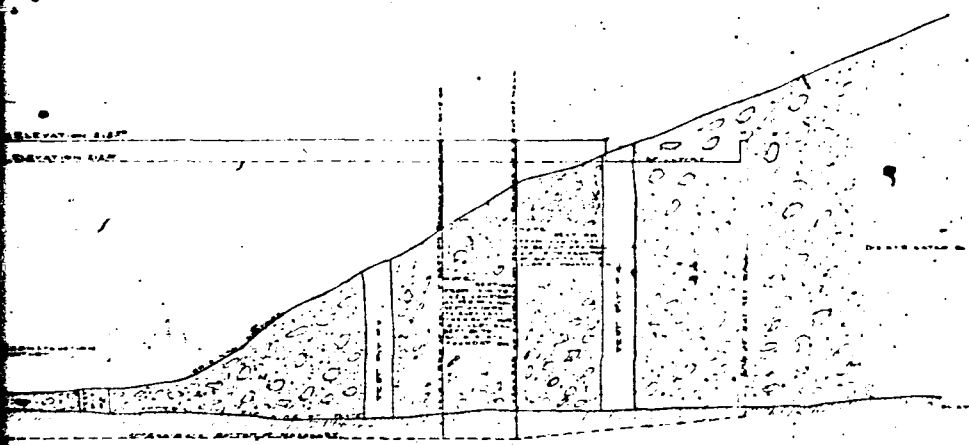
100-310  
 LONGITUDINAL SECTION  
 PROPOSED  
 HAYSTONE DAM  
 10-111  
 HAWK REFRAC TOXIES COMPANY  
 10-111  
 SCALE 1/4" = 1'-0"  
 10-111

Figure 3 shows the dam carried to a slate foundation across its length. Reportedly, the rock foundation is excavated to a depth of 4 to 5 feet with the bottom of the trench being stepped to offer greater sliding resistance. Additionally, several feet of earth backfill was apparently placed at the downstream toe.
